Subject: **Milwaukee County Fleet Garage – Condition Assessment Report
10320 W. Watertown Plank Road, Milwaukee, Wisconsin
ZS Project No.: 7523**

The following is a report of the ZS assessment of the main roof systems at the Milwaukee County Fleet Management maintenance and vehicle storage garage in Milwaukee, Wisconsin.

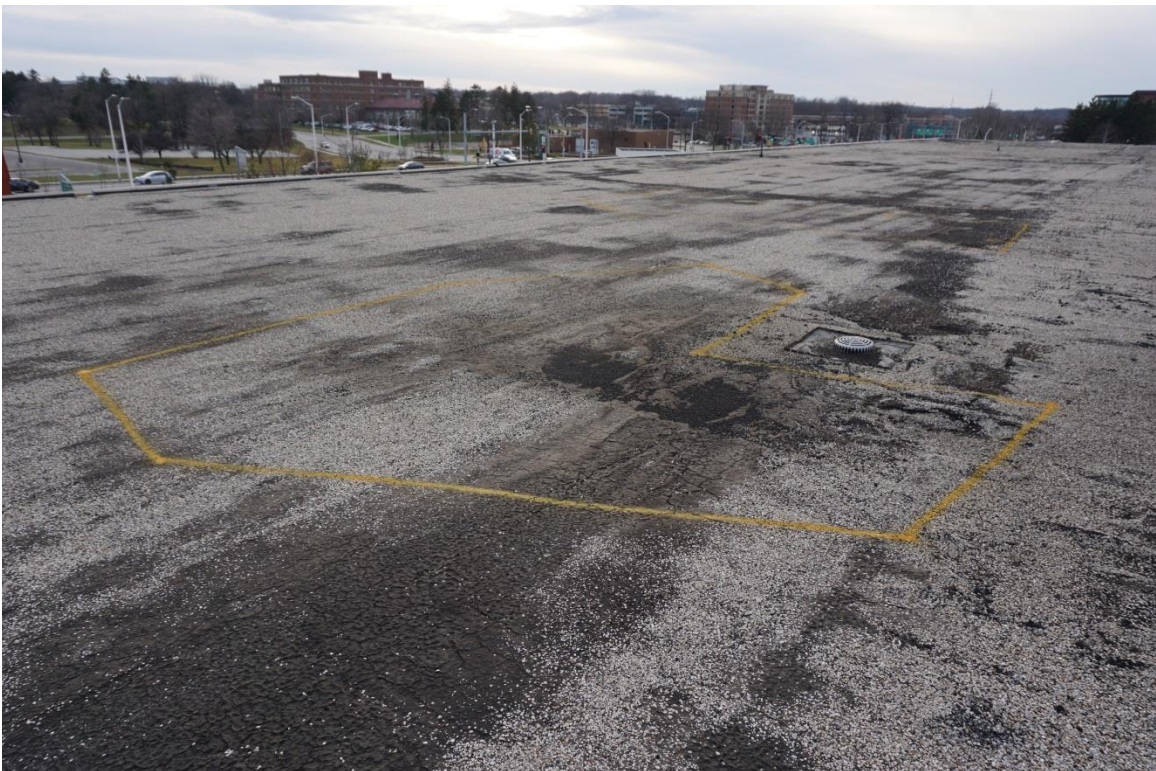
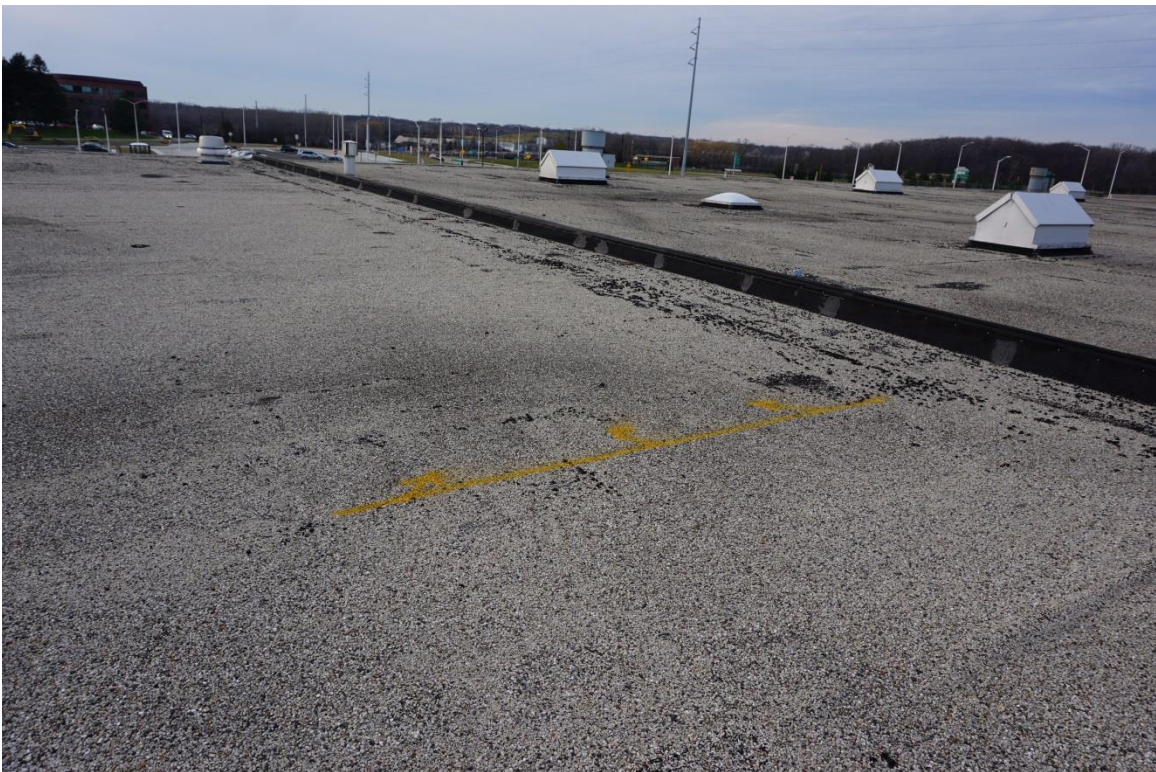
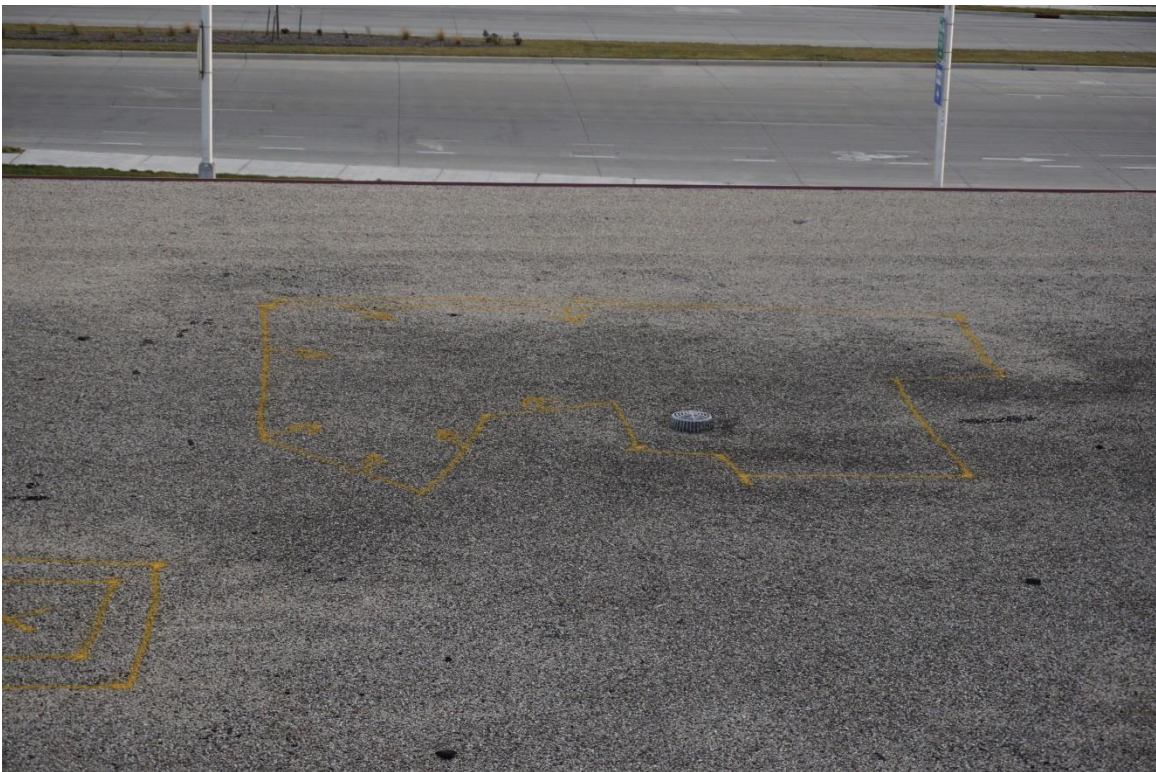
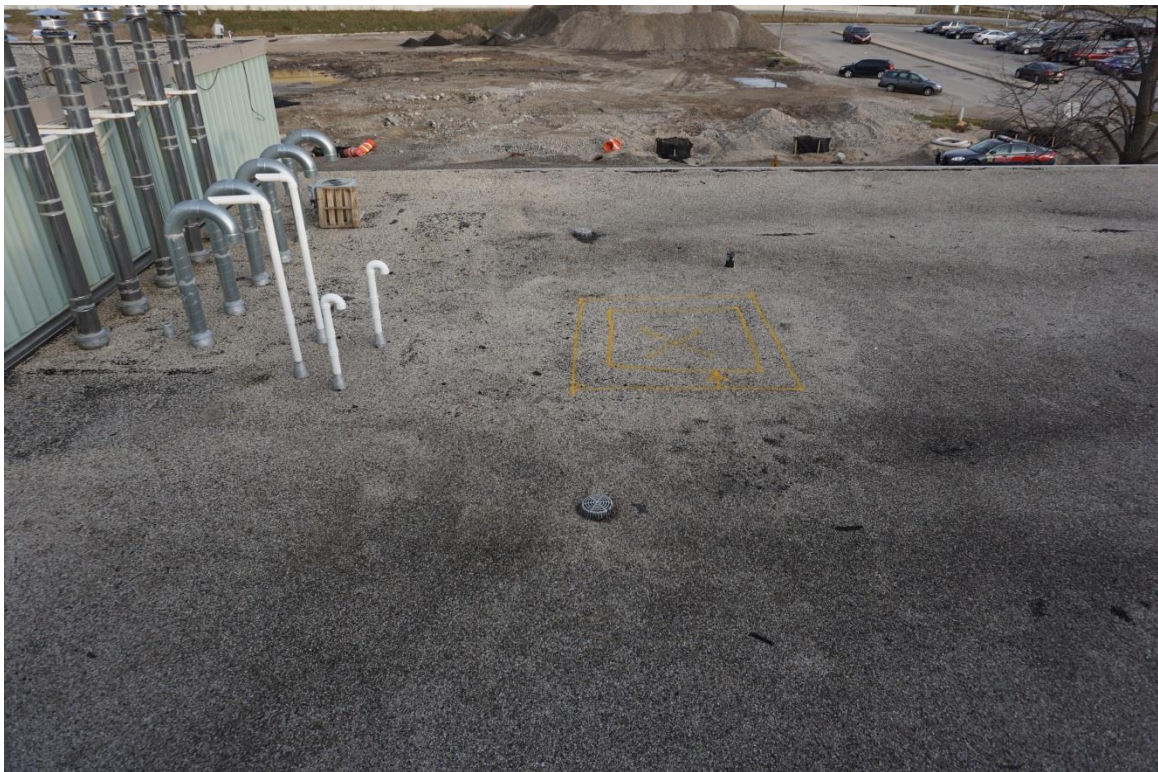
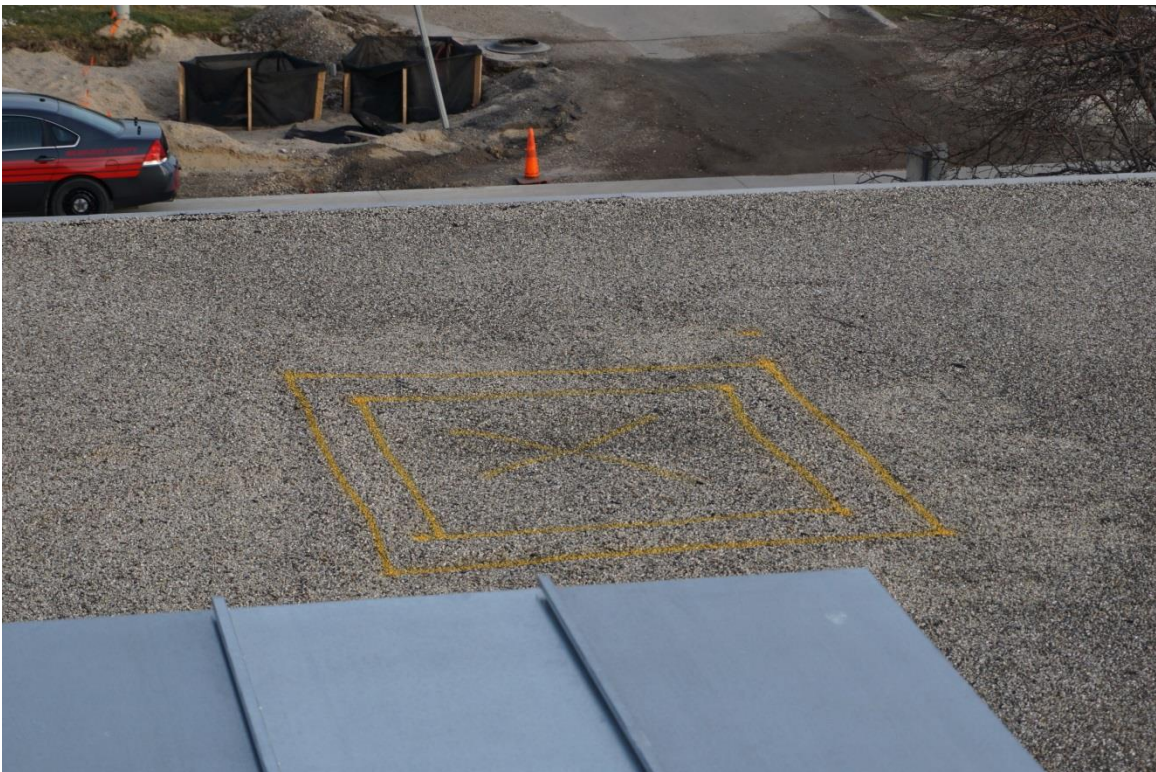
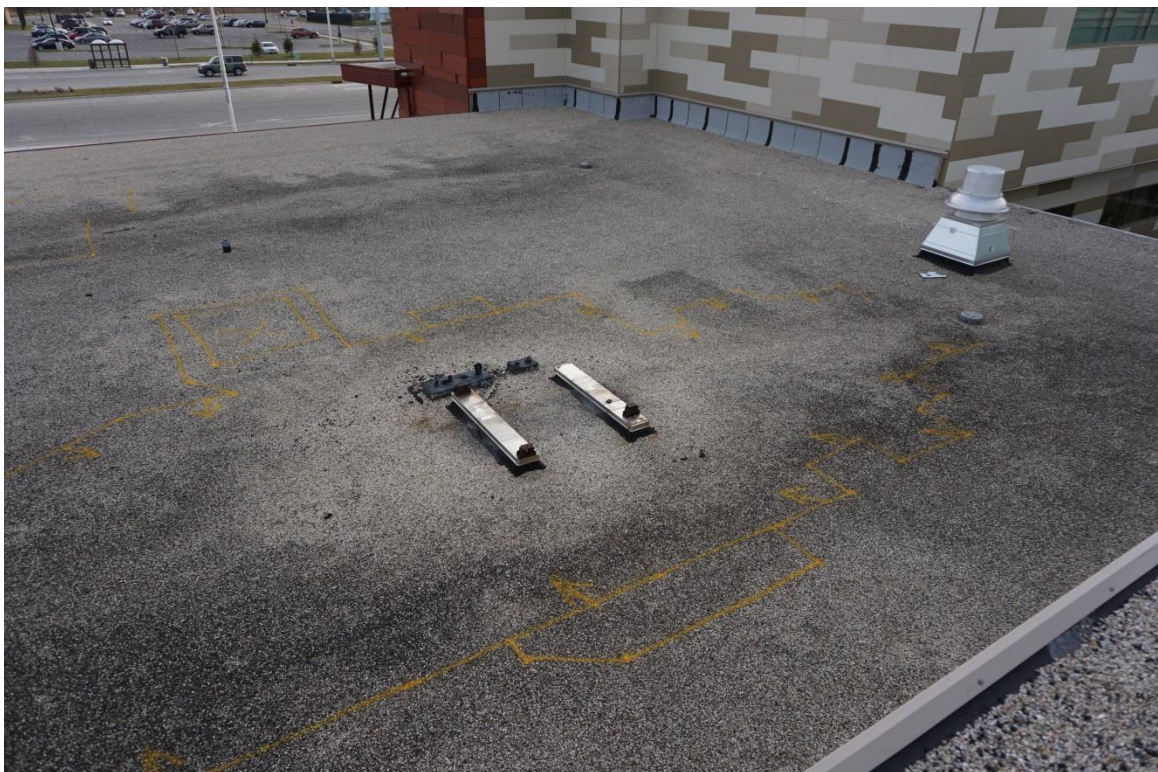
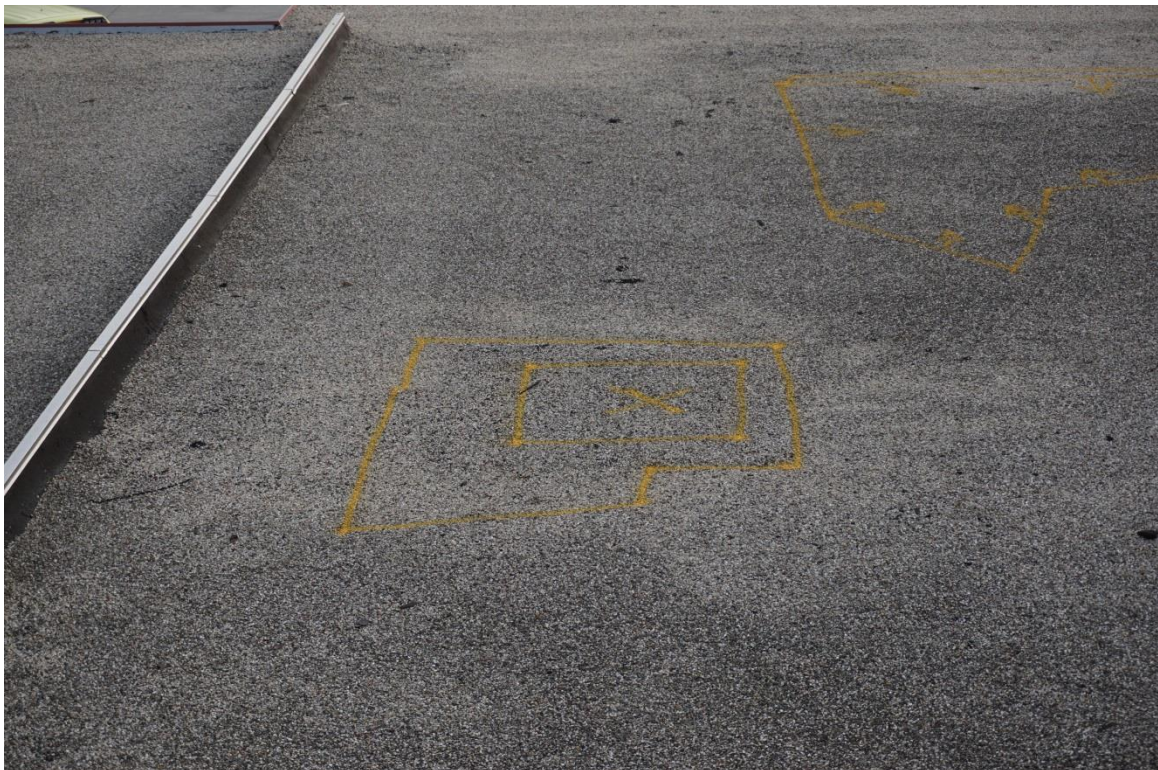
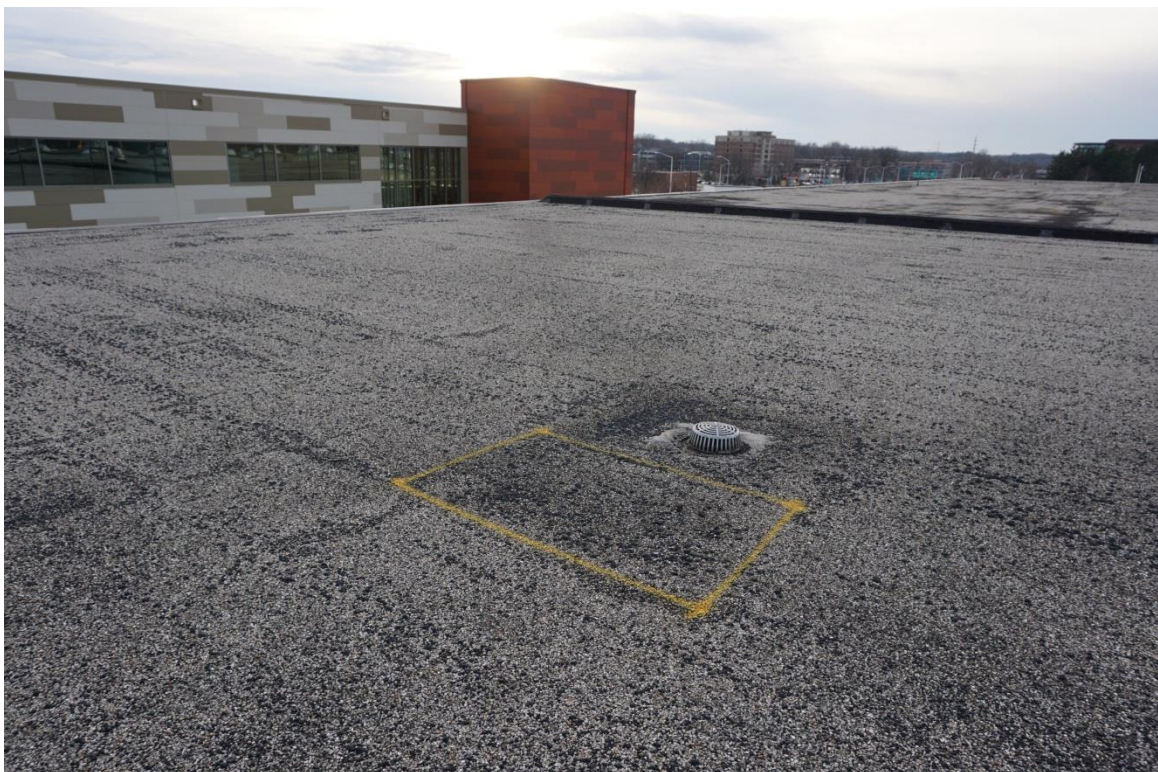
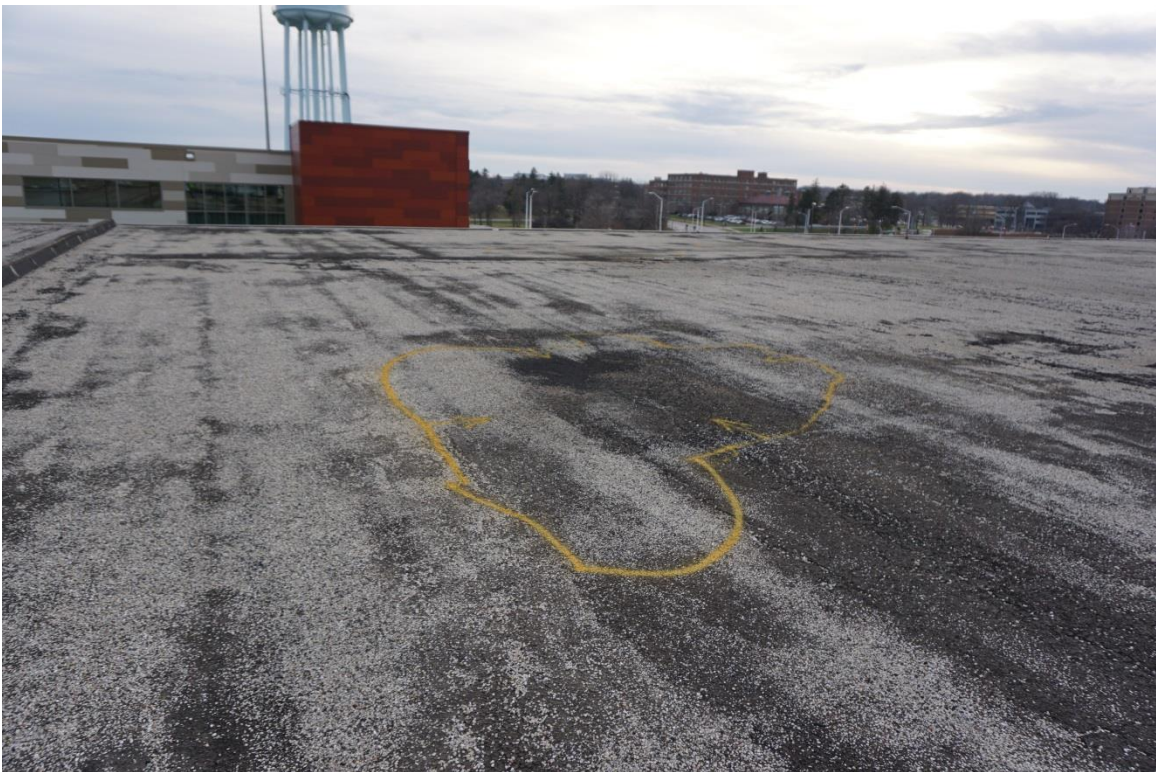
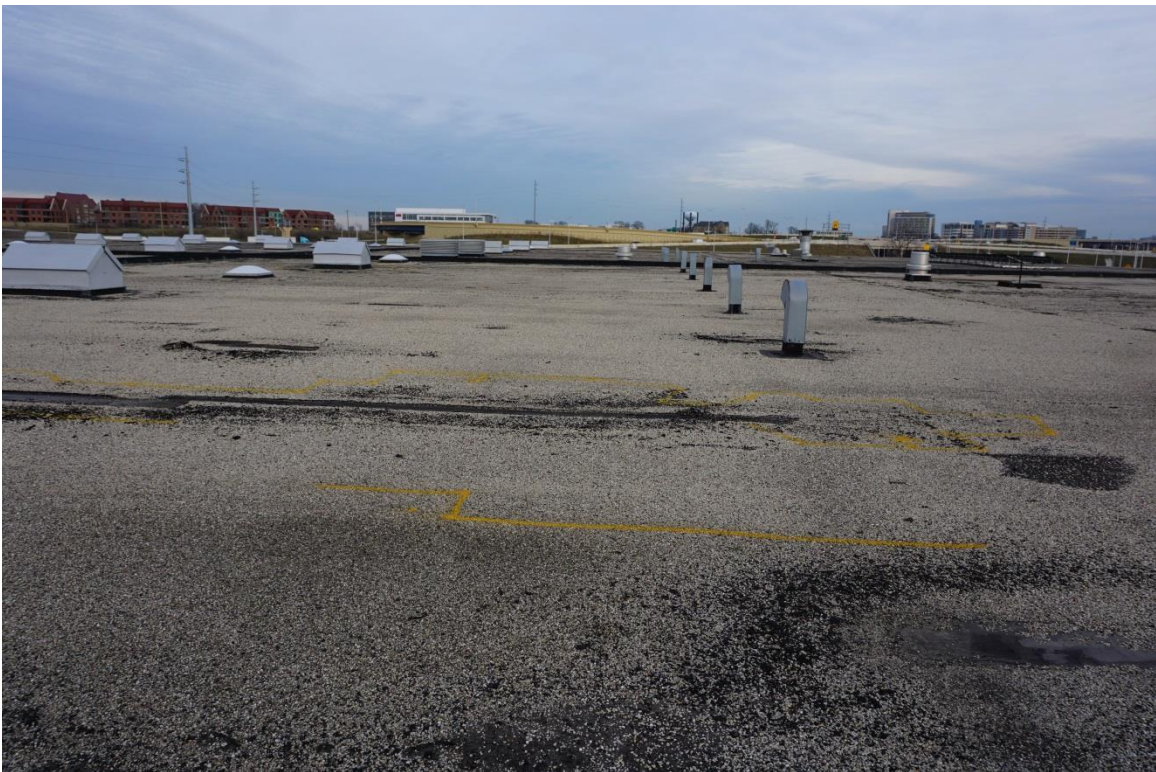
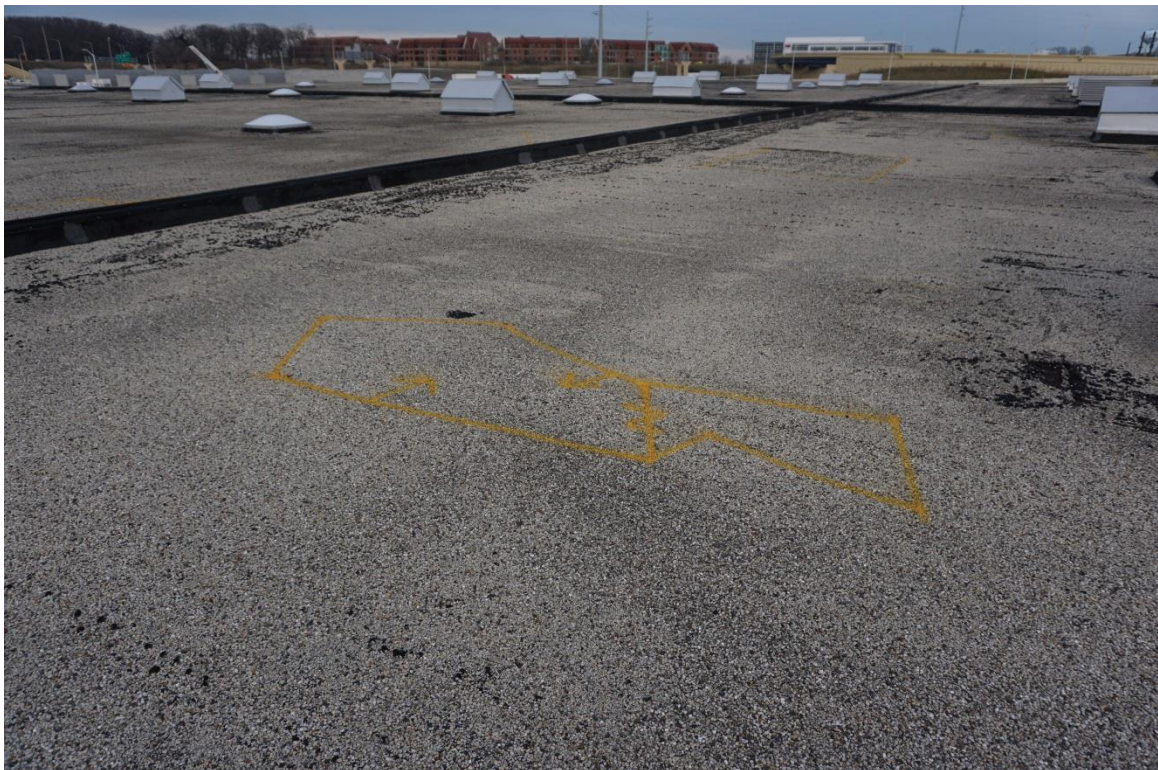
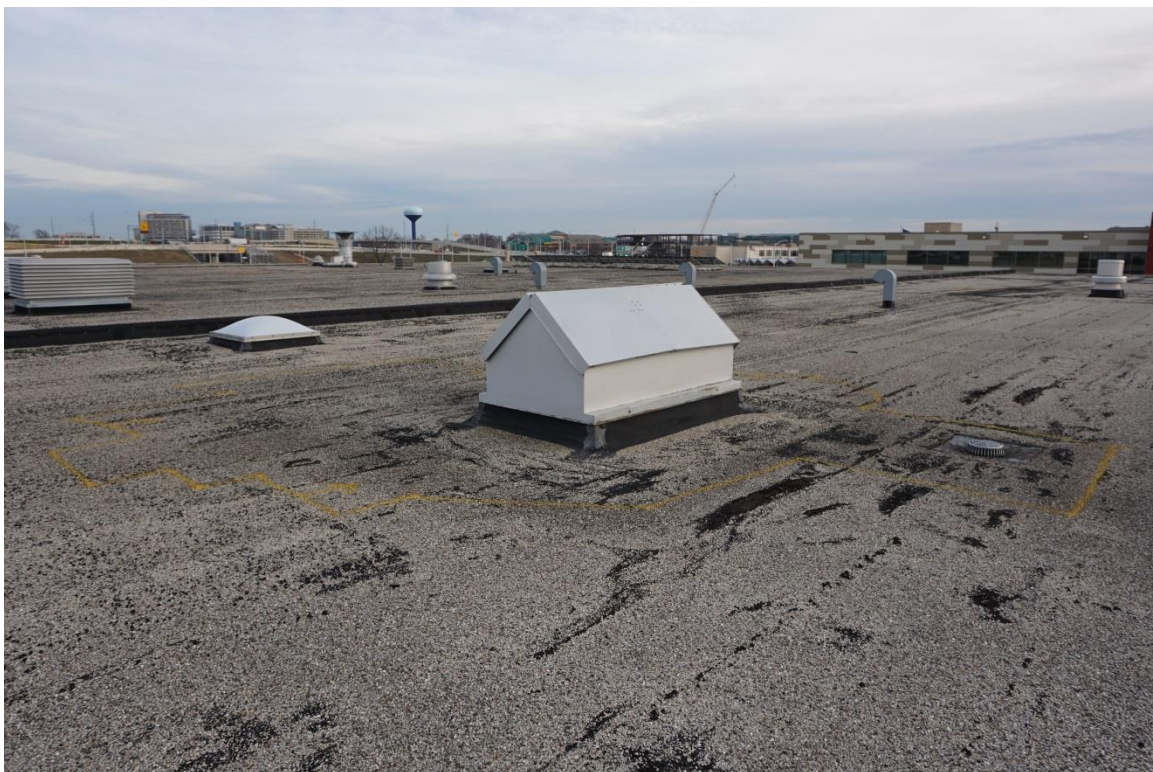
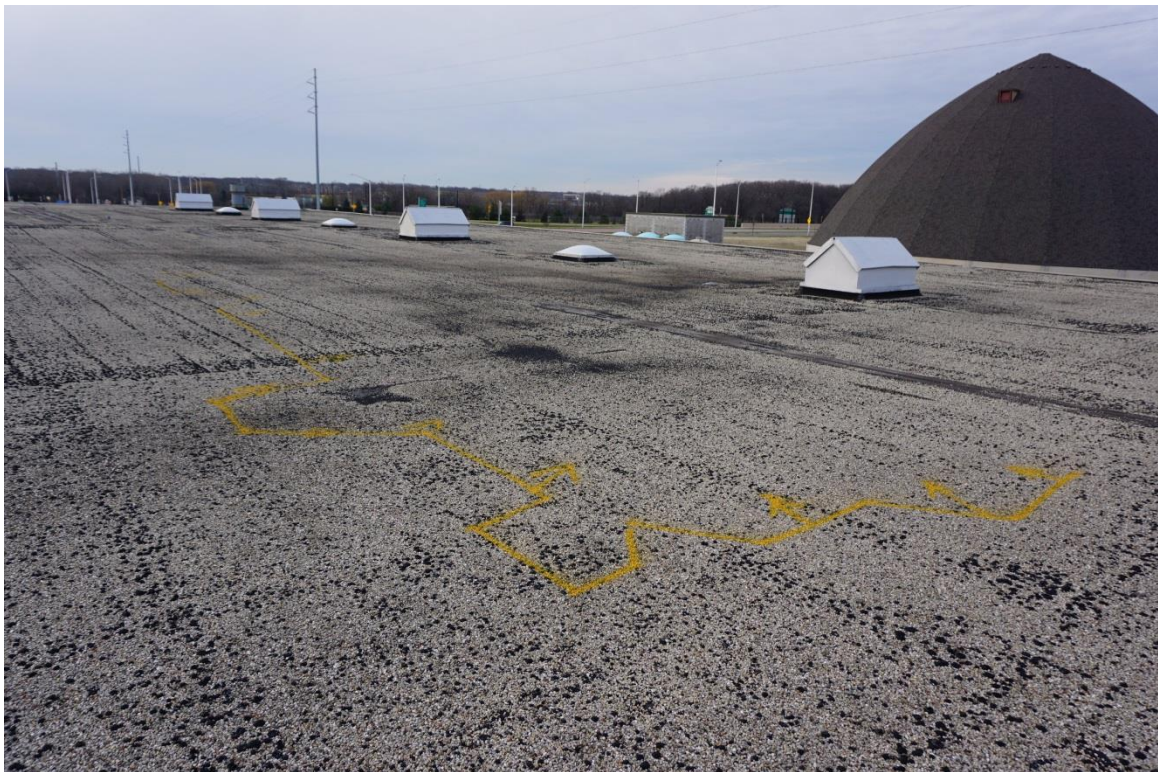
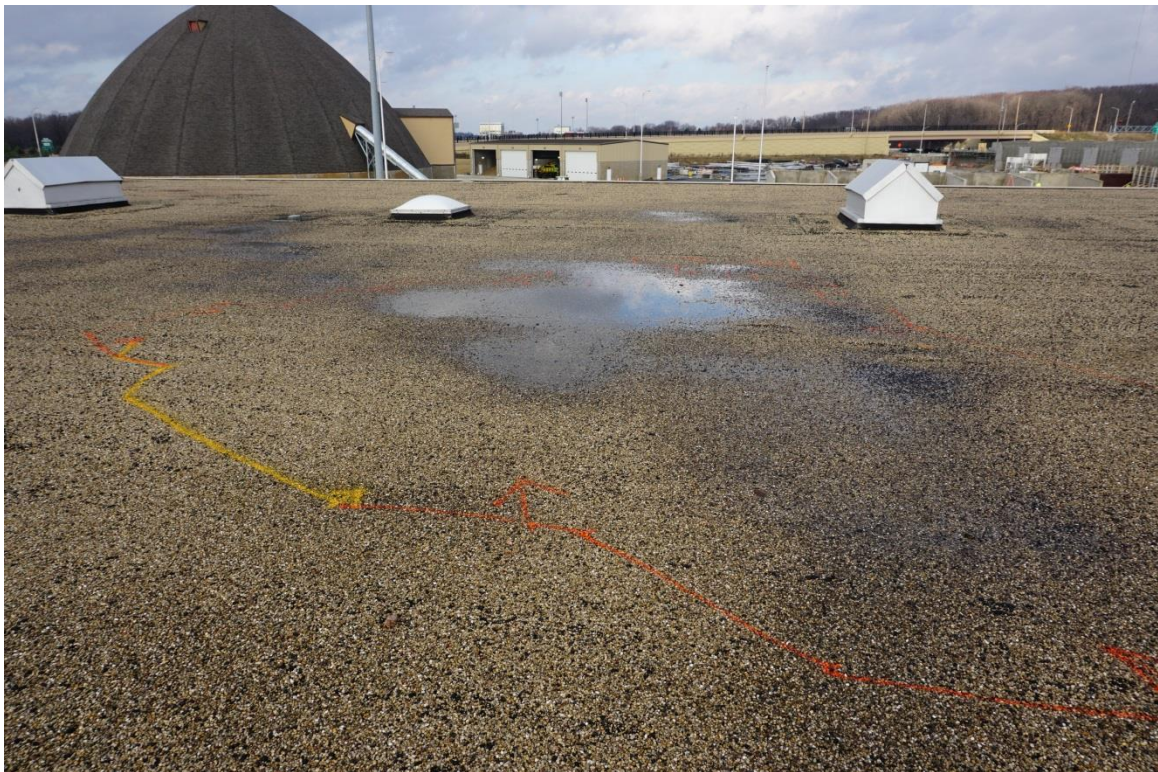
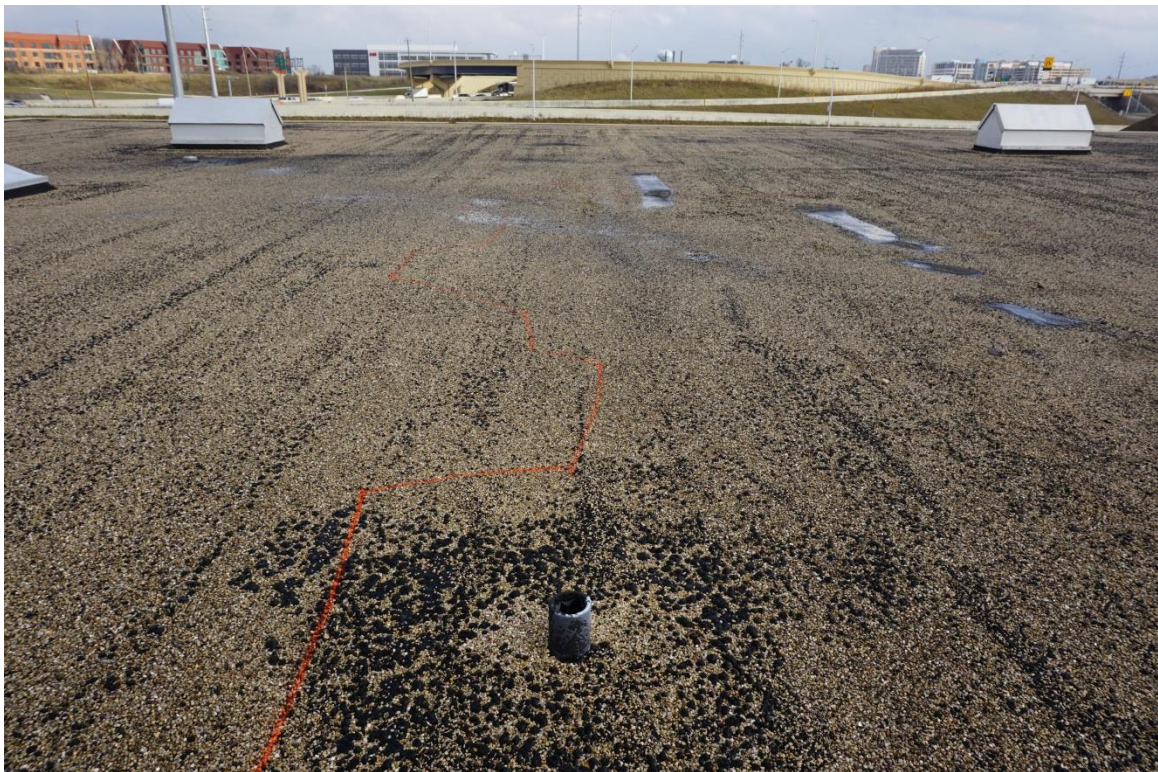
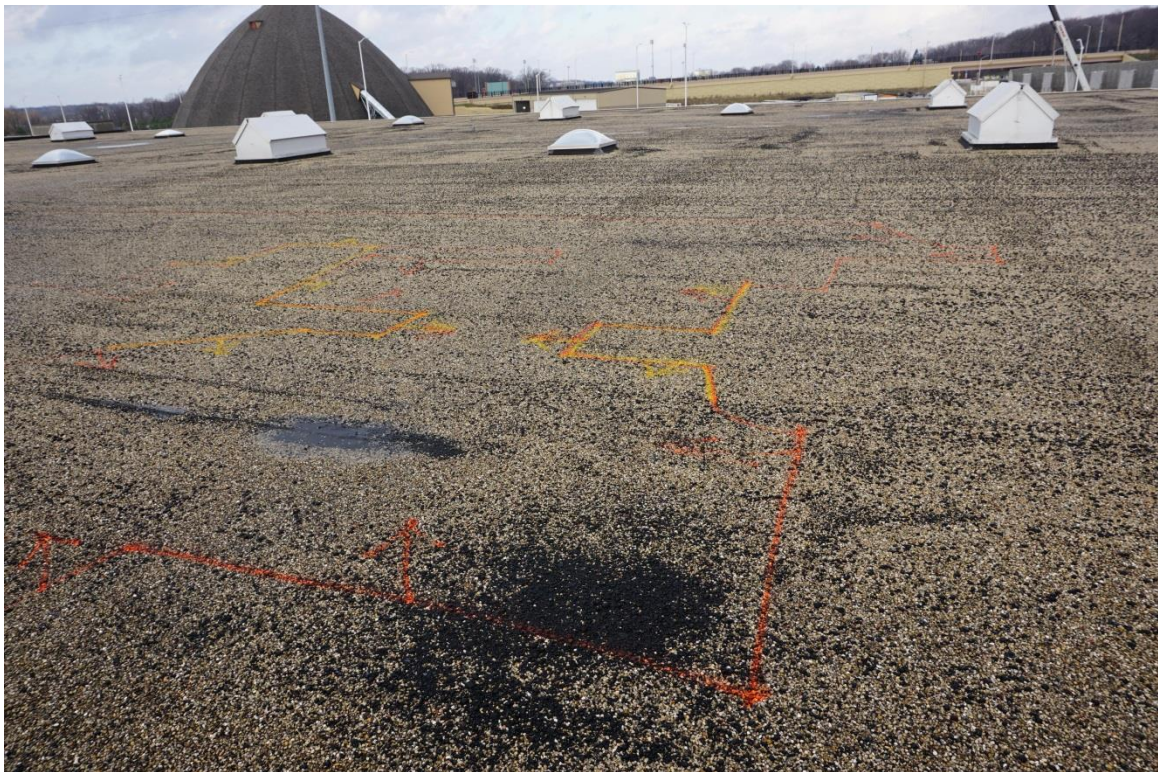
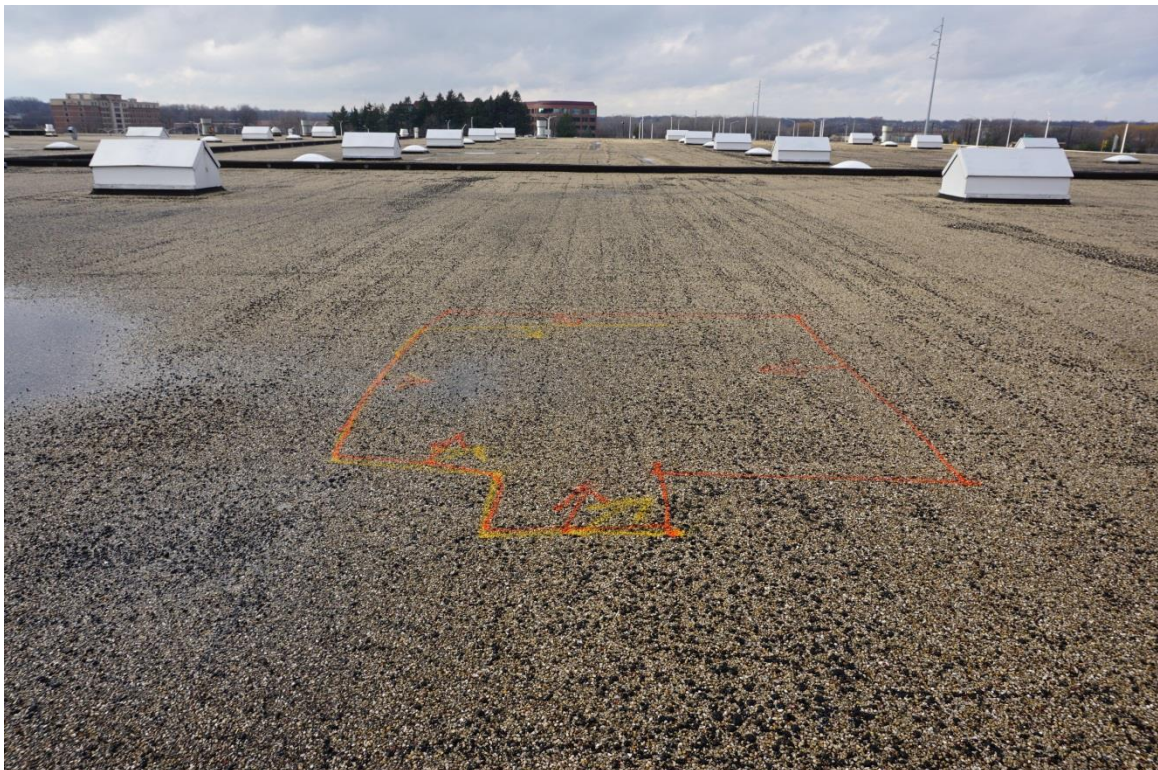
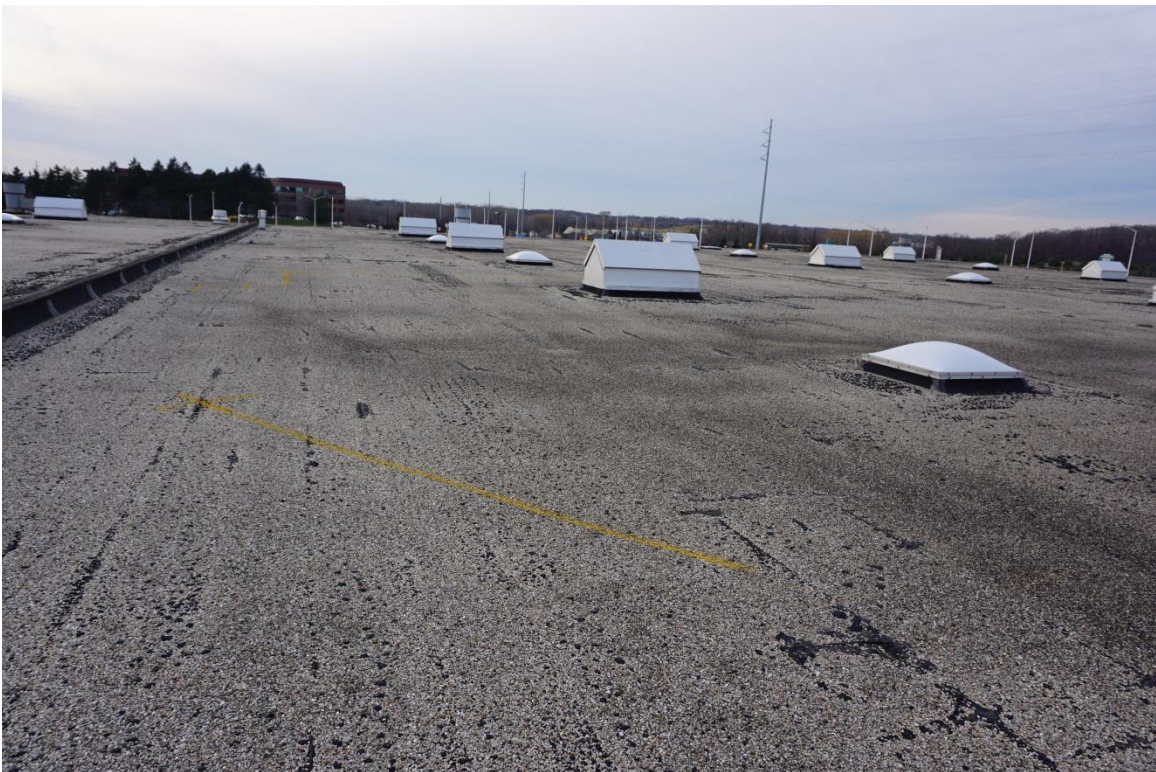
- Thermal anomalies were observed at multiple locations in the field of the roof. Large areas of thermal anomalies were observed in various locations under various conditions, often but not always corresponding to areas of puddling water. See Appendix B for locations and photos (Figures 19-55) for the thermal anomalies.

Figure 20: Roof area at thermal anomaly.

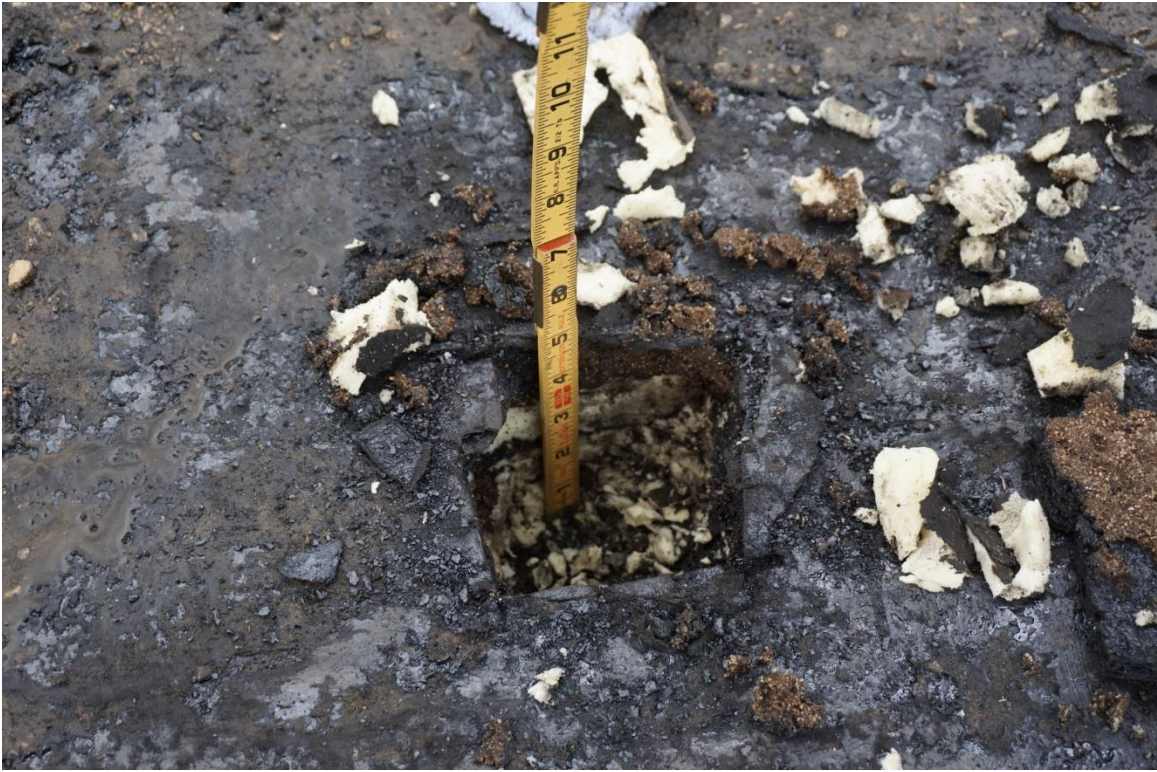
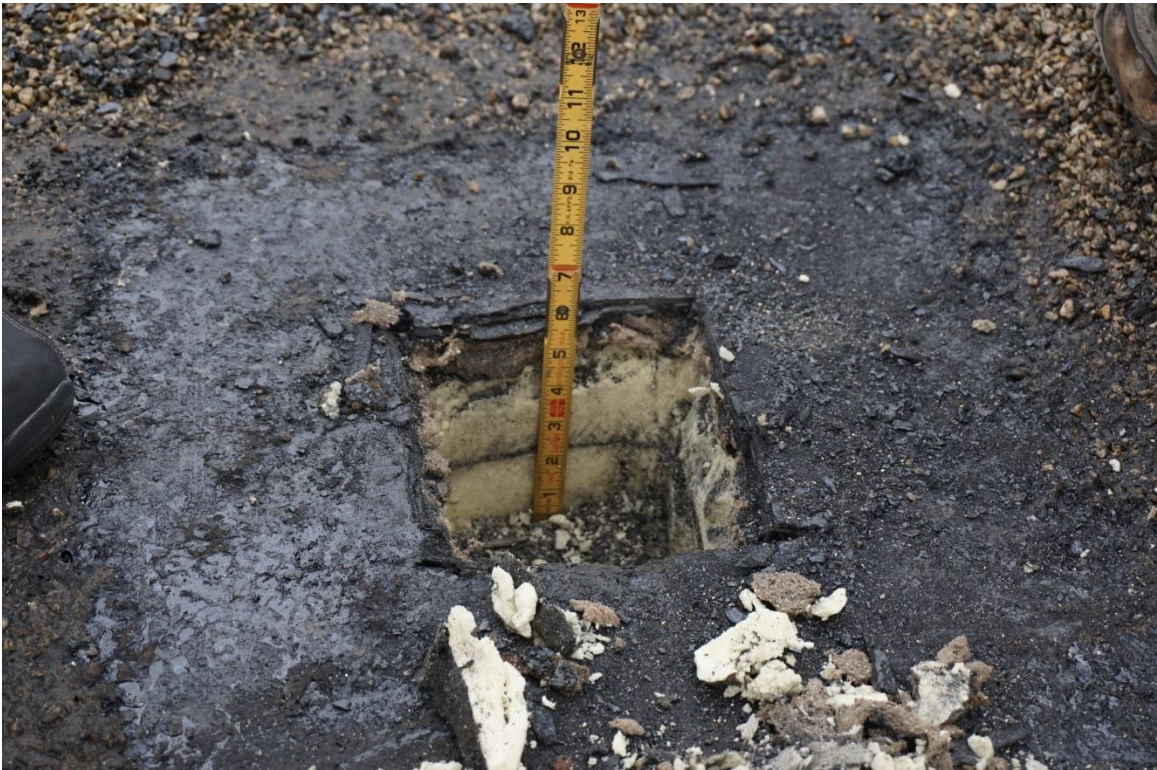
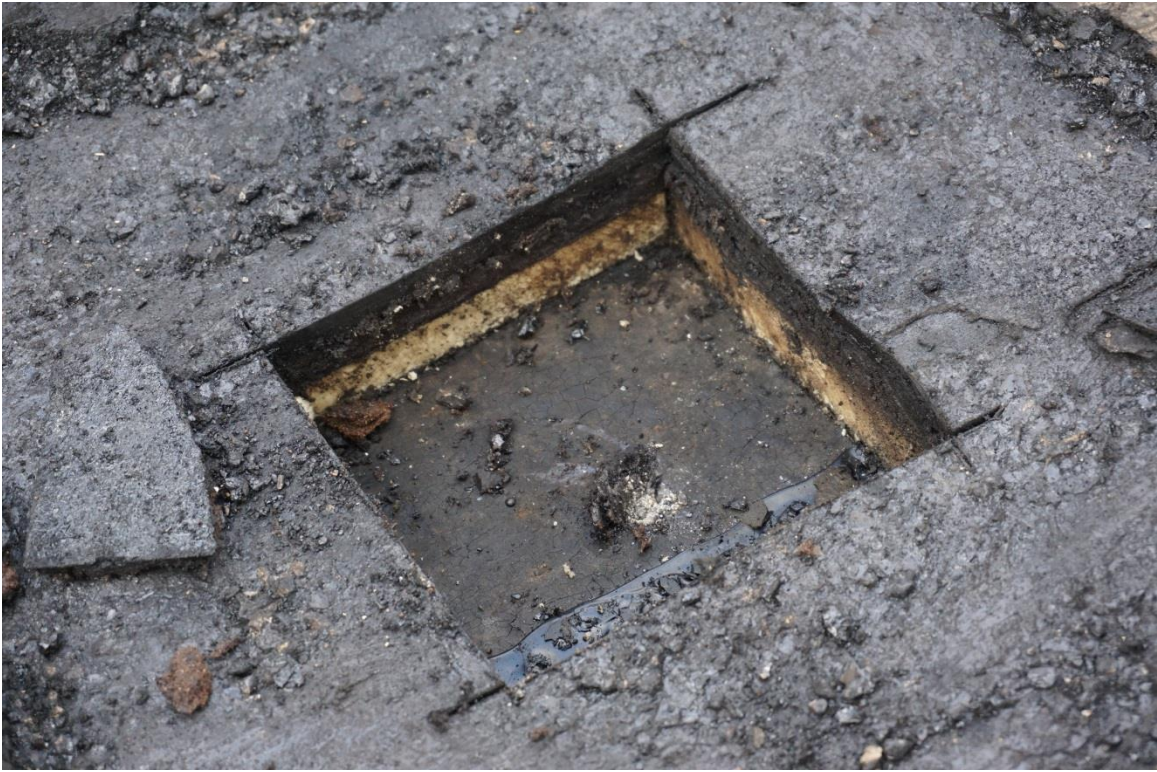
- Openings 1,3,4,5,6 were made at areas of suspected wet insulation based on the IR survey. All displayed saturated insulation and fiber board topping. See Figures 56-58.
- Opening 4 also revealed ponding water beneath the insulation and above the tectum deck base layer (Figure 59).
- Opening 2 was made at an area of suspected dry insulation based on the IR survey. This location showed no sign of moisture and was dry (Figure 60).
- Opening 6 revealed a joint between wet and dry fiber board topping sections, however the insulation beneath was saturated with water throughout the entirety of the opening (Figure 61).

Figure 56: Roof Inspection Opening.

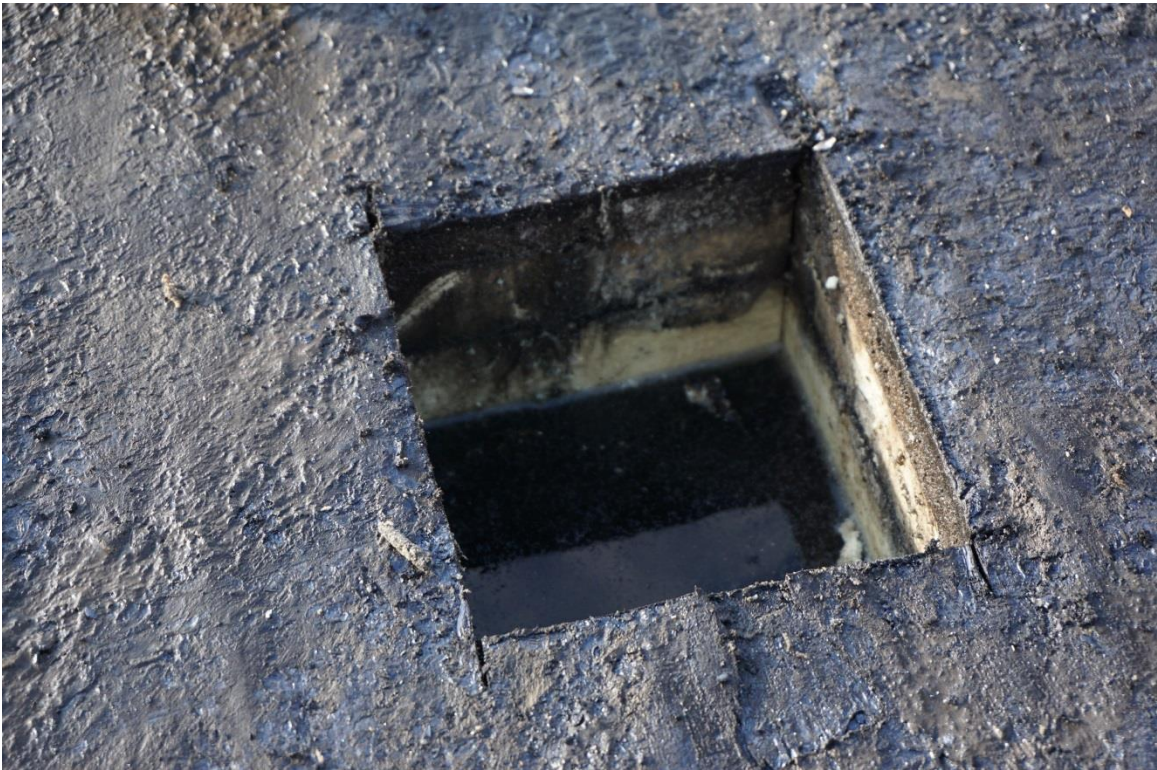
Figure 59: Roof Inspection Opening.

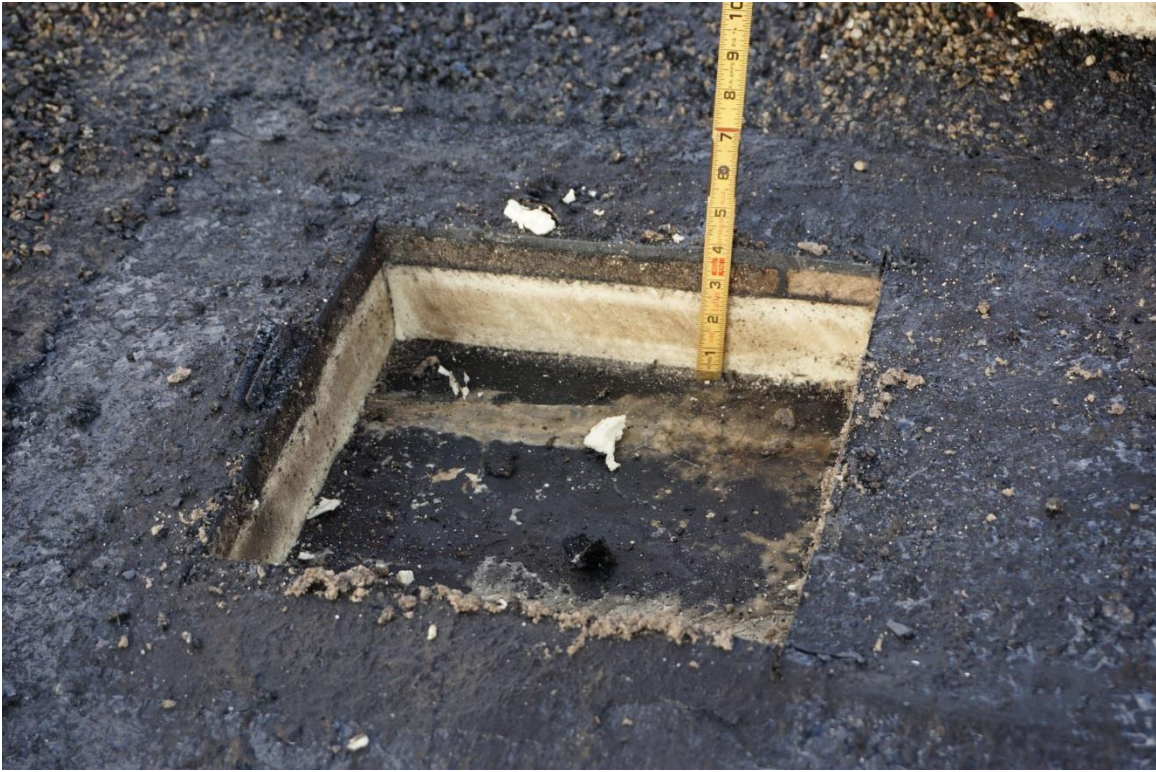
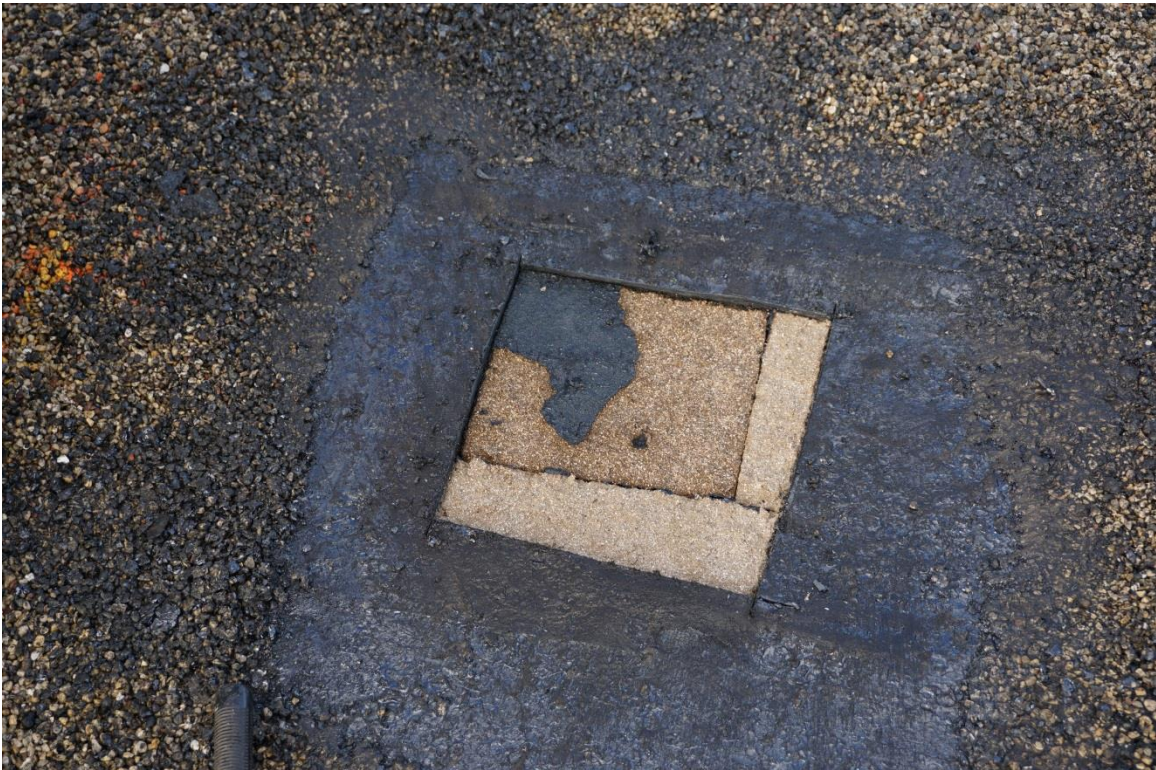
Figure 60: Roof Inspection Opening.

Figure 61: Roof Inspection Opening.
